TroubleShooting AVIATOR

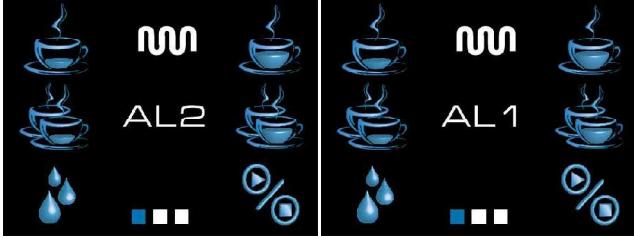
PROBLEMA	SOLUZIONE
Sul Display appaiono gli allarmi AL1 o AL2.

<p>Verificare che la macchina sia dotata di sistema multiboiler (TCI). Nel caso <u>non</u> fosse dotata di tale optional accedere al menù tecnico, raggiungere la funzione “TCI” e settarla su “Disable”. Nel caso la macchina ne fosse dotata verificare la sonda di temperatura della caldaia caffè relativa al gruppo su cui è apparso l'allarme.</p> <p>AL1 = sonda di temperatura interrotta</p> <p>In questo caso verificare i collegamenti tra sonda e centralina. Se i collegamenti risultano corretti ed integri sostituire la sonda.</p> <p>AL2 = sonda di temperatura in corto circuito; sostituire la sonda di temperatura.</p>
Sul Display, nella schermata di stand-by, appare l'allarme AL1 o AL2 nell'angolo in basso a sinistra.

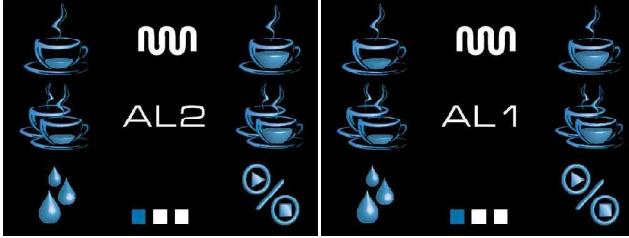
PROBLEM	SOLUTION
On the Display appears the alarms AL1 or AL2

Check if the machine is equipped with Multi-boiler system (TCI). If it's <u>not</u> equipped with this option you have to enter into the technical menu, reach the "TCI" function and set it to "Disable". If the machine it's equipped with this option you have to check the temperature probe of the coffee boiler for the group on which appeared the alarm. AL1 = temperature probe interrupted; check the connections between the probe and the electronic box. If the connections are correct and undamaged replace the probe. AL2 = temperature probe short circuit; replace the temperature probe.
On the display, in the stand-by screen, appears the alarms AL1 or AL2 appears in the lower left corner.
